**Docket No. 217 – Development and Management Plan Inspection**

**Norwalk Substation**

**Date:** March 2, 2006

### Plumtree Substation

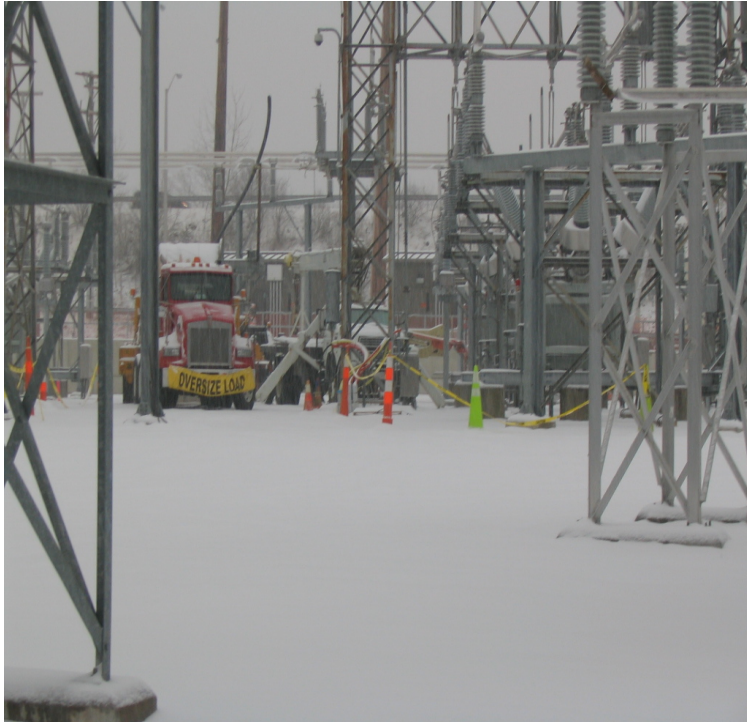
Norwalk Substation: Photo on the left shows work continuing within the live yard. Photo on the right shows where erosion controls were left in place following soil testing across the Norwalk River. This work is not technically reviewed under the current phase of work. 3/2/06.

| Areas of Inspection | Observation | Recommended Action |
|---|--|--|
| Foundation construction | - Little "soil-disturbing" work was occurring on site. Some structural and electrical work was ongoing in and near the GIS building. Some work continues on adjacent structures. 2/9-3/2/06.<br><br>- Some work continues within the live yard. 3/2/06 | -None at this time. The site remains largely contained. 3/2/06.<br><br>- None at this time. Work remains controlled. 3/2/06 |

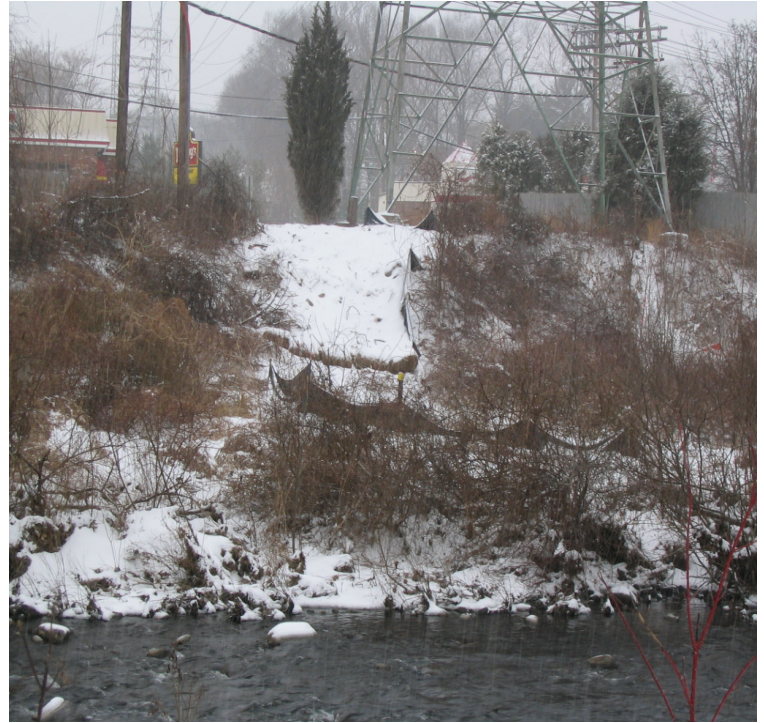
| Areas of Inspection | Observation | Recommended Action |
|--|--|---|
| Erosion and Sediment Controls continued | ramp. 3/2/06<br>-Erosion controls remain in place across the Norwalk River as a result of soil testing. This was not immediately part of the substation work. 2/22-3/2/06. | related to road sanding. 3/2/06<br>-This is not under the jurisdiction of the current substation work docket. 2/2-3/2/06. |

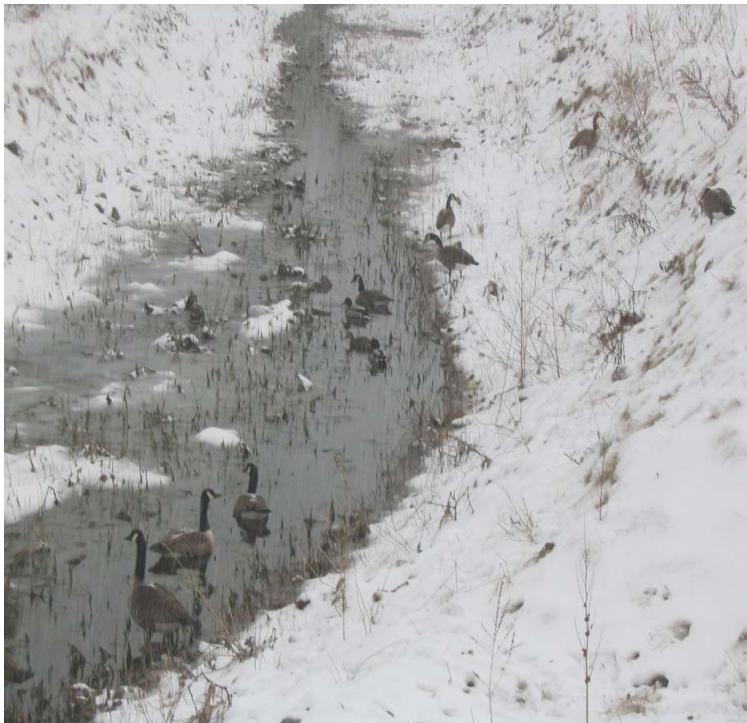
| Areas of Inspection | Observation | Recommended Action |
|---|--|---|
| Additional Observations | - Numerous waterfowl were noted in the constructed channel. 3/2/06 | - The channel appears to provide some beneficial wildlife value. 3/2/06 |

Photo on the left shows the use of the constructed overflow swale by waterfowl. Photo on the right shows the access drive to Plumtree Substation where trenching for the 345kV XLPE portion of the project is occurring. Work is well contained to the driveway at this time. 3/2/06

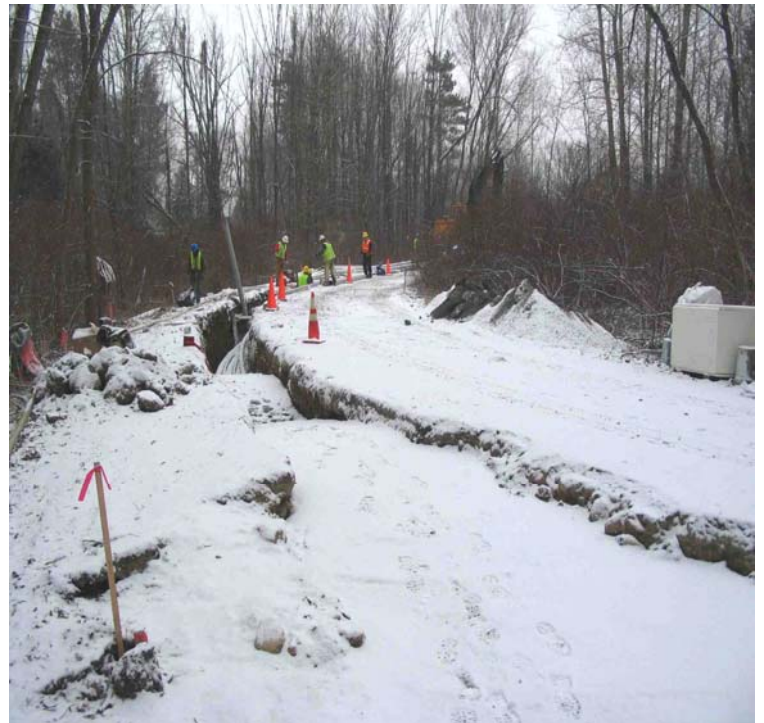
| Areas of Inspection | Observation | Recommended Action |
|---|---|--|
| Access Roads | - Trenching continued in the driveway to the substation as part of the 345kV XLPE work. 2/23-3/2/06. | - Work remains well contained and does not involve the substation yard. 3/2/06<br>-If the driveway needs to be plowed, keep snow/sediment piles away from the wetland swales adjacent to the driveway. 1/4-3/2/06. |
